NASA / CR-2001-211242

# Runway Incursion Prevention System ADS-B and DGPS Data Link Analysis Dallas – Ft. Worth International Airport

*J. Timmerman*  
*Rockwell Collins, Cedar Rapids, Iowa*

November 2001

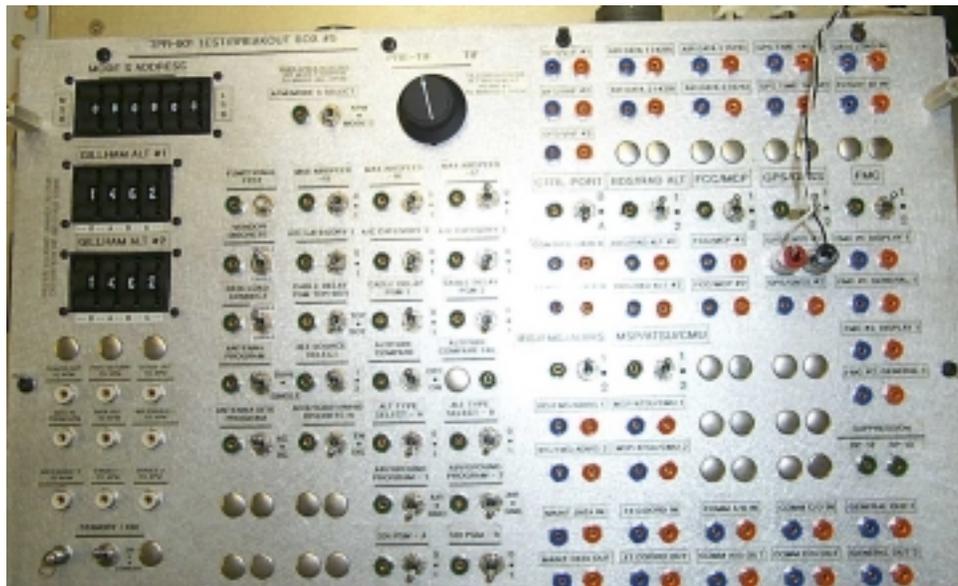
Figure 3-3: ADS-B Transmit Pallet Breakout Box

The pallet contained a breakout box (Figure 3-3) that interfaced with the transponder to provide easy access to ARINC-429 data buses and transponder configuration pins. This breakout box could be used with either a 718-4 or a 718-A transponder. Since a 718-A transponder was being used, ARINC-429 labels for altitude (Label 203) and Flight ID (Labels 233, 234, 235, and 236) were required as inputs. The label definitions can be found in reference [1]. In addition, in order to receive LAAS correction messages, a tuning label (Label 033) was required as an input to the GNLU-930. These labels were provided using the Datatrac 400H. The breakout box was also used to set the following transponder configurations: Mode S ICAO address, maximum airspeed, aircraft category, altitude type and source, and air/ground (weight on wheels) status. The control head was used to change the 4-digit transponder code, which was assigned by air traffic control on a nightly basis during the RIPS flight tests at DFW.

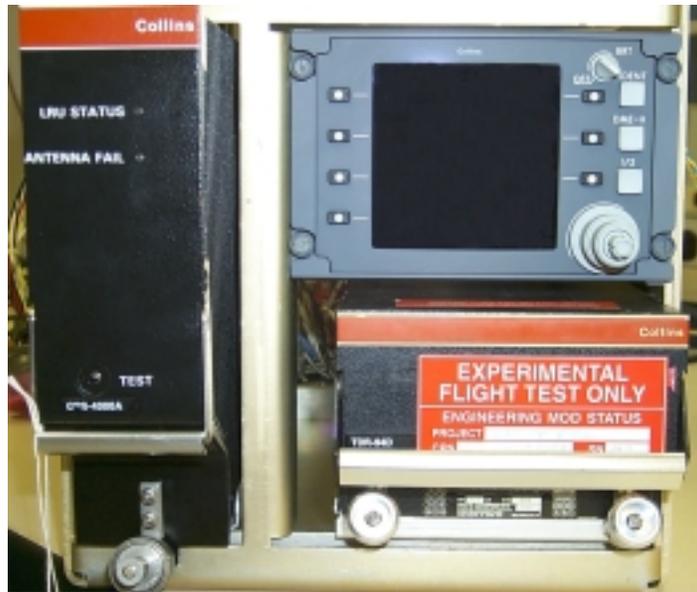
**Figure 3-4: AGATE ADS-B Transmit Pallet**

During RIPS tests at DFW, a second ADS-B source was used for interoperability testing. This source was an ADS-B pallet developed for the Advanced General Aviation Transport Experiment (AGATE) program. The pallet, shown in Figure 3-4, contained the following Rockwell Collins equipment: a GPS-4000A receiver, a TDR-94D transponder, and an RTU-4220. The pallet also contained an altitude encoder. The GPS receiver was not using the LAAS differential corrections broadcast from the Ohio University ground station. The RTU (Radio Tuning Unit) was used to control the transponder and display the altitude provided by the altitude encoder. This pallet was installed in a trailer located near the East control tower. Thus, it was a stationary target, and was not used in any incursion scenario tests or during the RIPS demonstrations. The purpose for testing with the AGATE ADS-B pallet was to validate interoperability of this pallet, intended for use on general aviation aircraft, e.g., the AGATE 1B aircraft, with the RIPS system and ADS-B installations on air transport category aircraft such as the NASA ARIES 757. Tests confirmed full interoperability of the AGATE ADS-B flight test system with the NASA ARIES 757. The NASA ARIES aircraft received approximately 60 to 70 percent of all messages broadcast by the AGATE ADS-B pallet. This reception rate is quite good considering the non-optimal antenna placement on the trailer located by the East control tower at DFW.
